## **INTERLEAVED BISMALIMIDE COMPOSITES**

Eileen Armstrong-Carroll and Thomas M. Donnellan  
Air Vehicle and Crew Systems Technology Department (Code 6064)  
NAVAL AIR WARFARE CENTER  
AIRCRAFT DIVISION WARMINSTER  
P.O. BOX 5152  
Warminster, PA 18974-0591

**1 DECEMBER 1992**

**FINAL REPORT**  
Period Covering July 1989 to May 1991  
P.E. 62234N  
P.N. RS-34ASO

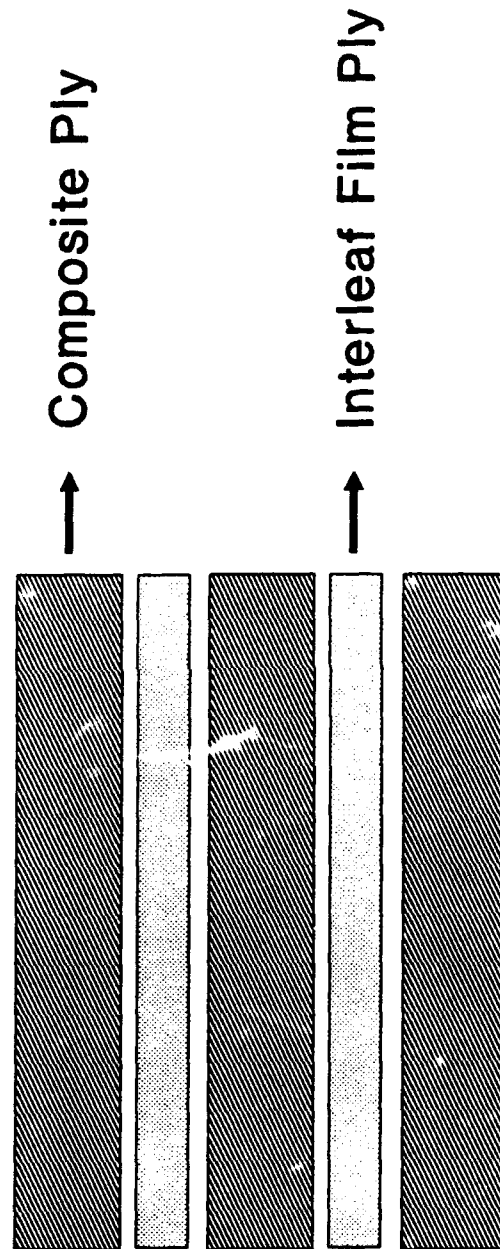
Figure 1. Illustration Of The Interleaving Concept.

Currently a number of approaches are being investigated for the improvement of the damage tolerance of brittle matrix composites. These approaches are resin formulation modification, through-thickness fibrous reinforcement, and interleaving. Formulation approaches center on the addition of ductile rubber or thermoplastic constituents to the resin which act to increase the fracture energy of the resin [2]. One variant of this approach is the formulation of multiple phase resins which separate spatially in the composite during processing [3]. Physical reinforcement approaches, such as stitching and braiding, improve impact resistance via out-of-plane fiber orientations [4]. These fiber orientations allow for more effective stress translation through the fibrous reinforcements after an impact event. With resin formulation and physical reinforcement techniques, some compromise in thermal stability or in-plane structural properties is accepted in order to improve the damage tolerance of the composite. The interleaving approach for improvement of damage tolerance involves the insertion of films of adhesive or thermoplastic materials at the interply interfaces in composite laminates. A schematic of an interleaved composite is depicted in Figure 1.

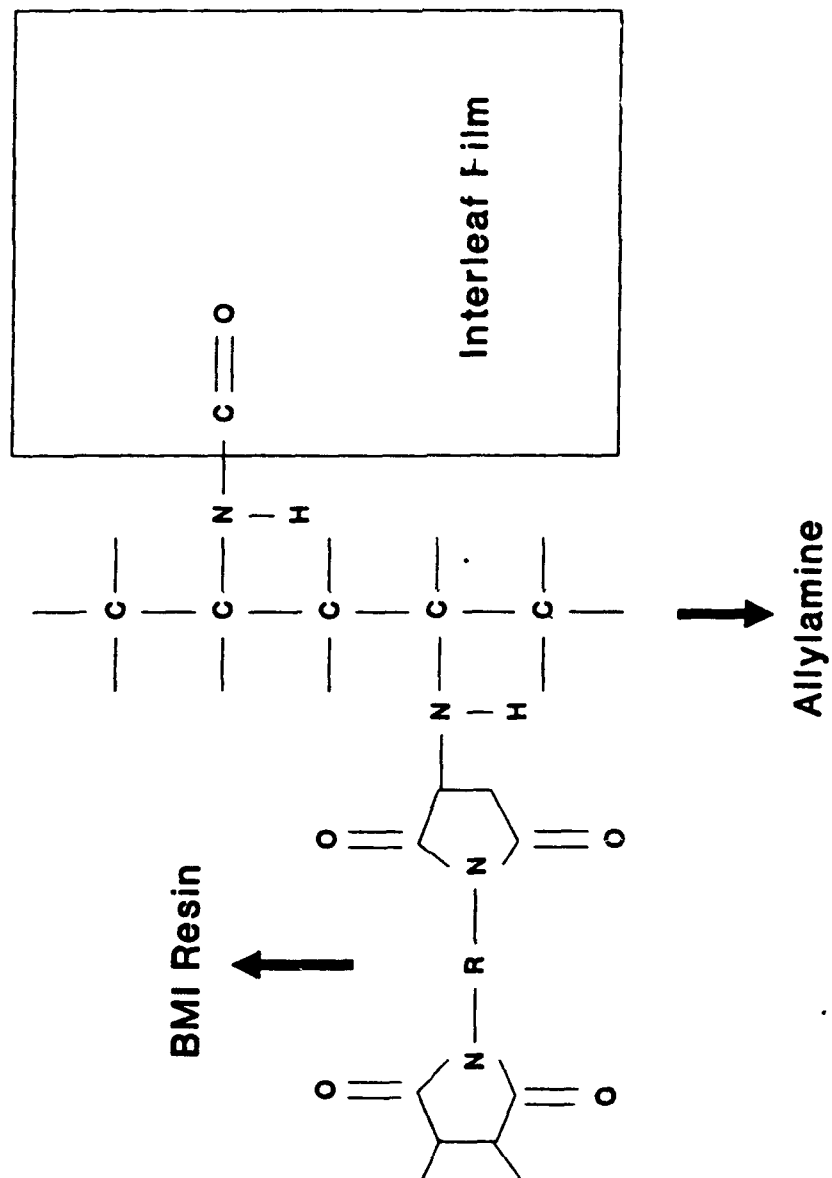
Figure 2. Possible Interleaf Film-Resin Bonding Mechanisms. Schematic Depicts How Grafted-Allylamine Polymer Acts As A Coupling Agent Between The Interleaf Film And BMI Resin.

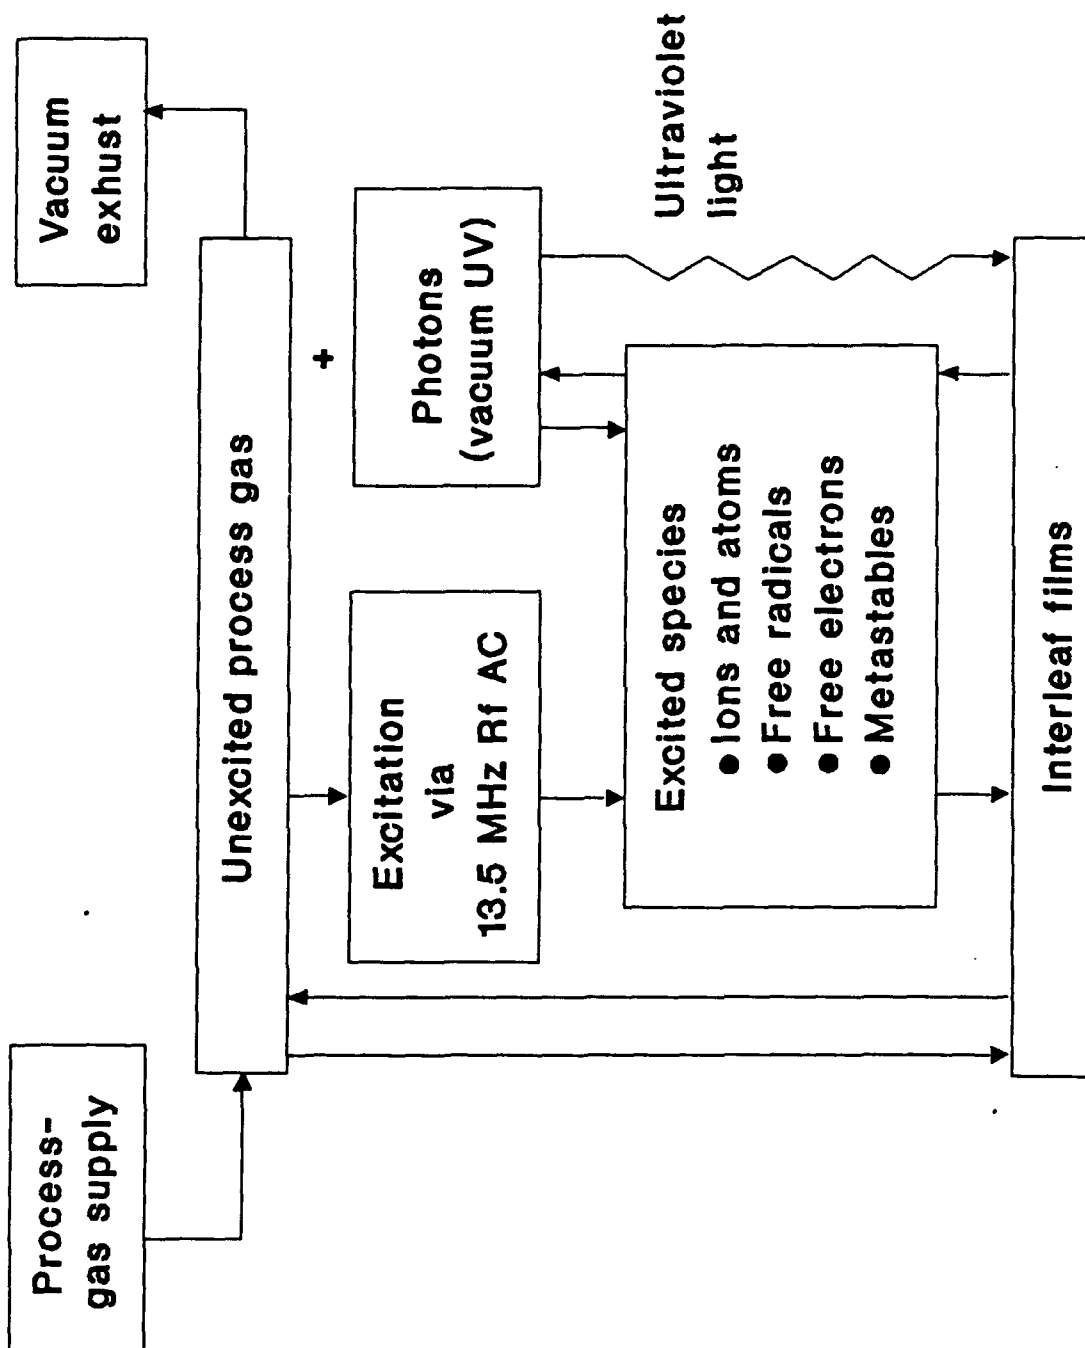
Figure 3. Schematic Of The Process Through Which Process Gases Are Excited And Deposited On The Interleaf Films.

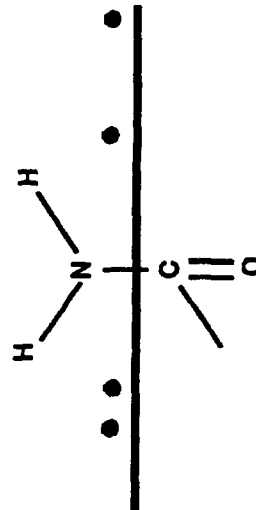
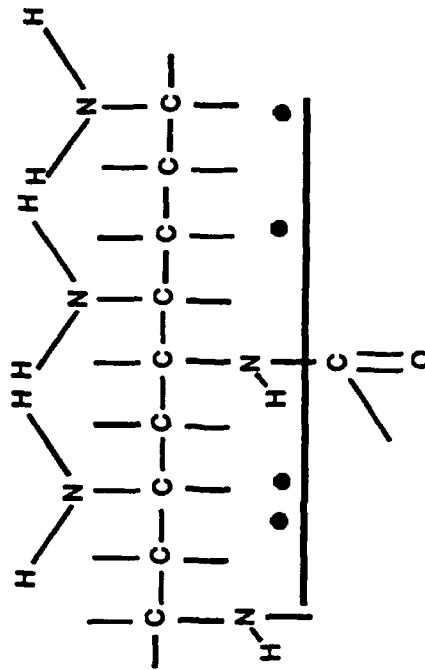
Figure 4. Possible Surface Chemistries Produced With Argon, Ammonia, And Allylamine Plasma Treatments. The Filled Circles Represent Carbonyl Free Radicals Formed During Plasma Treatment.

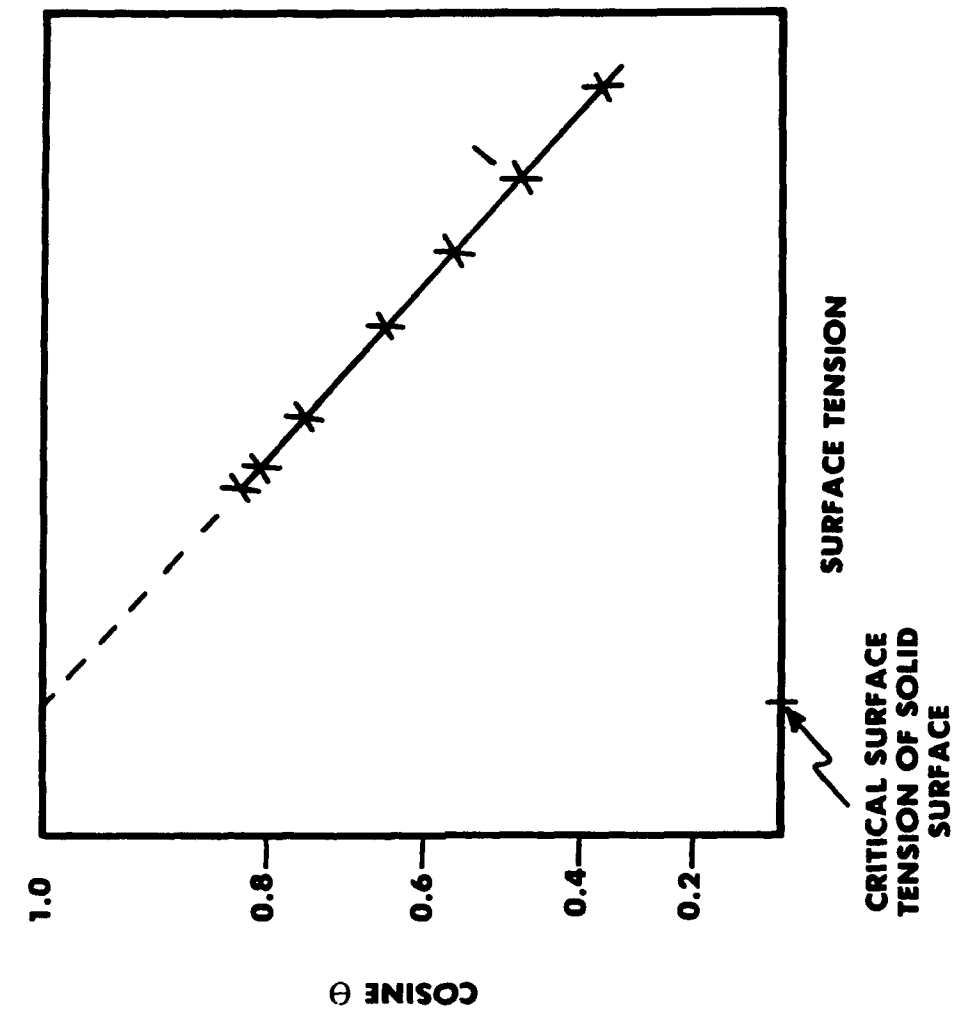
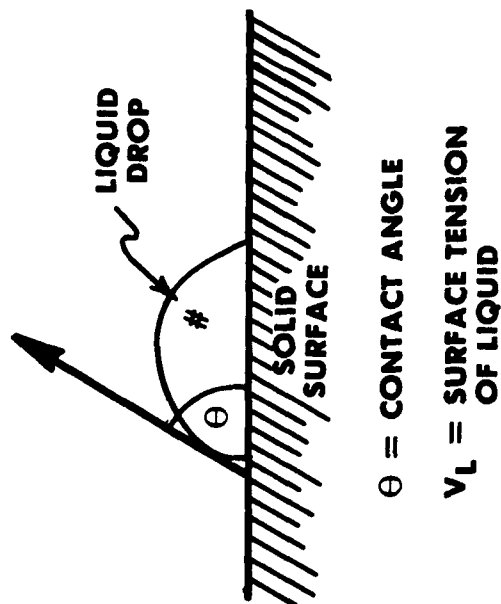
Figure 5. Illustration Of How Contact Angle Is Measured And Critical Surface Tension Is Determined.

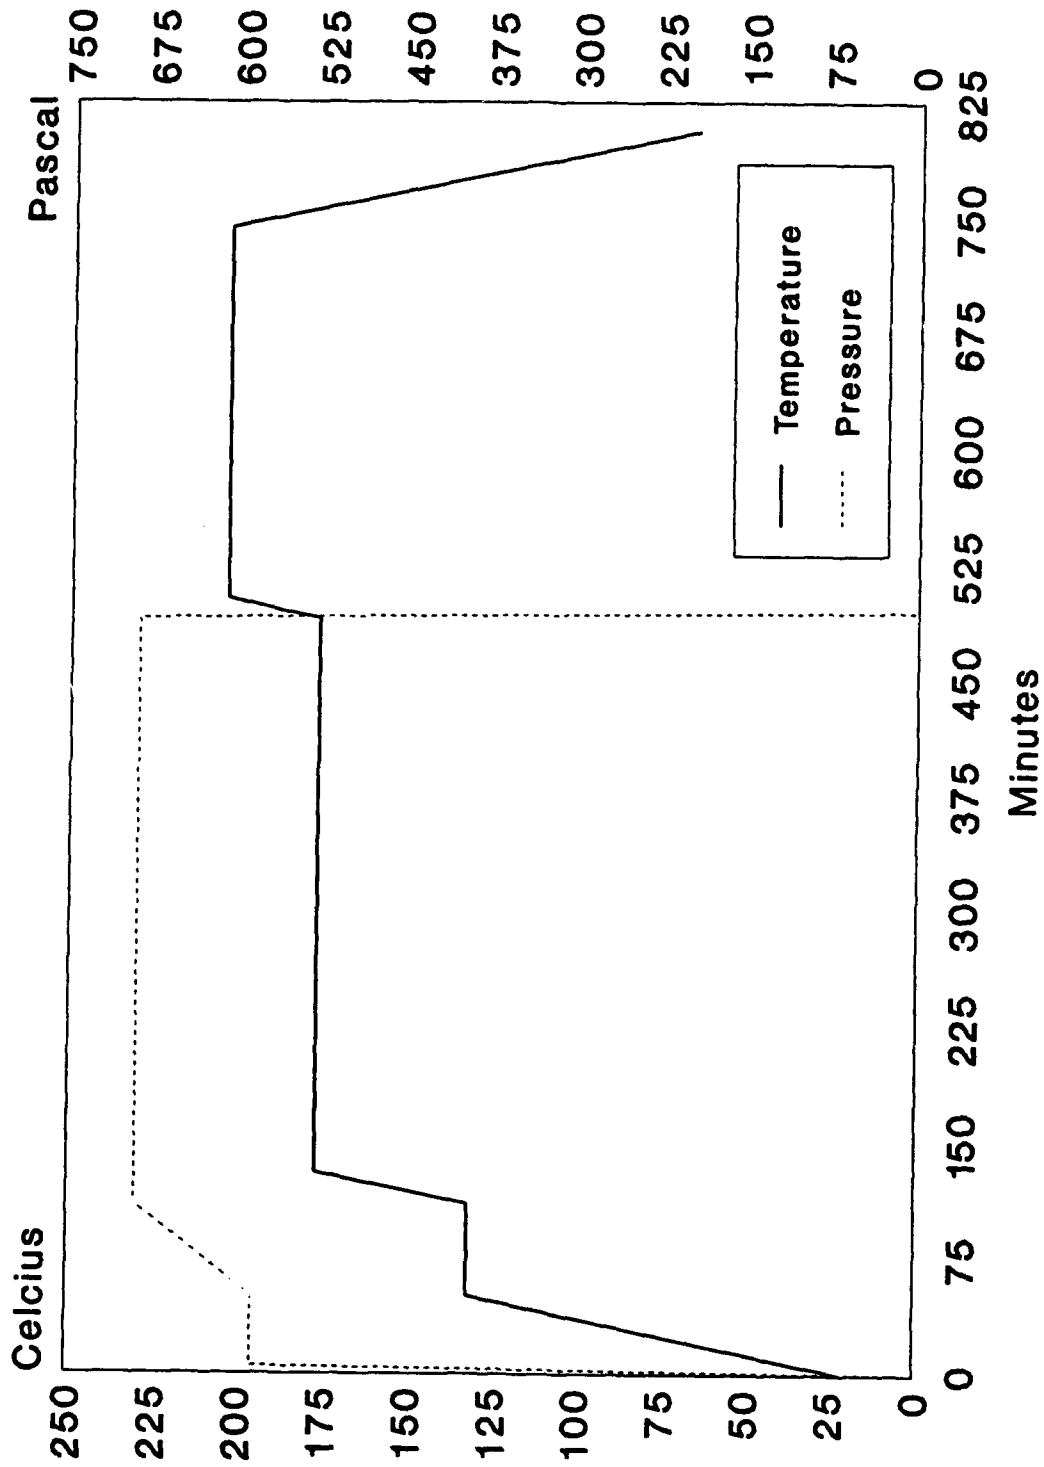
Figure 6. Processing Cycle For Interleaved Cycrom 3100/IM6.

All composite panels (including panels with no interleaf film) are processed with the recommended cure and post-cure procedures for interleaved Cycom 3100/IM6 developed by American Cyanamid. The processing cycle is diagrammed in Figure 6.

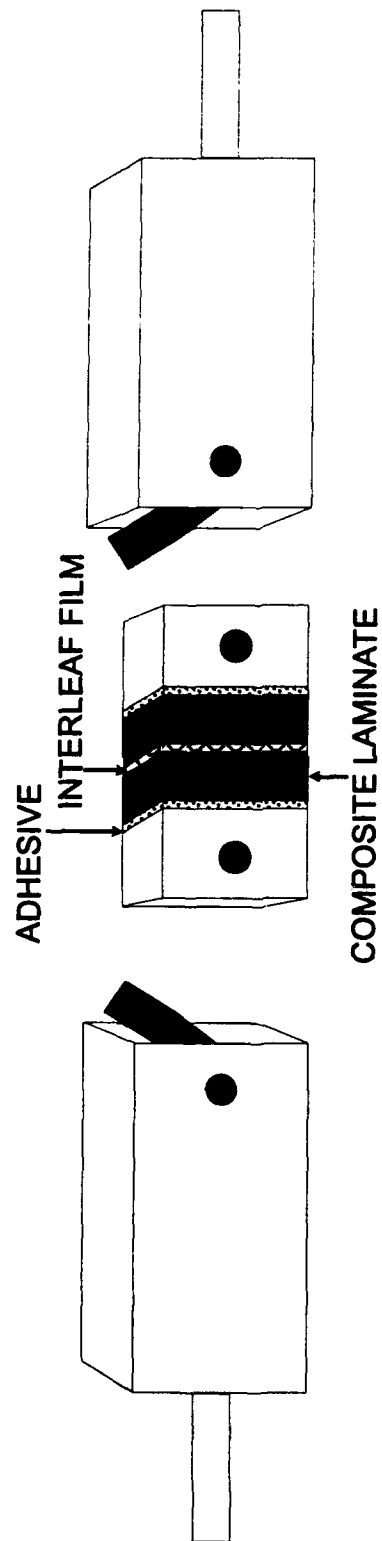
Figure 7. Schematic Of The Flatwise Tension Test Set-Up.

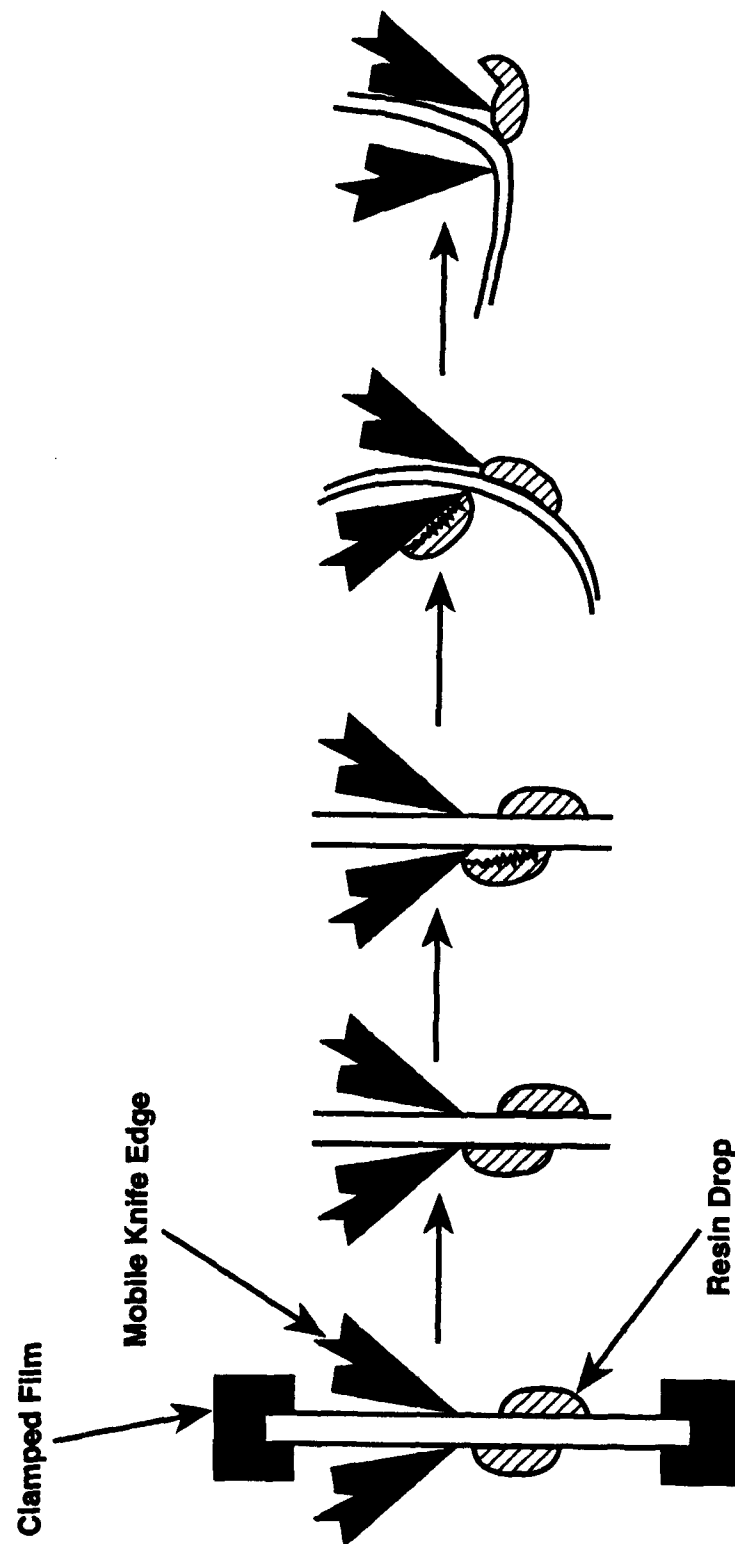
Figure 8. Depiction Of The Typical Test Sequence For The Resin-Drop Shear Test.

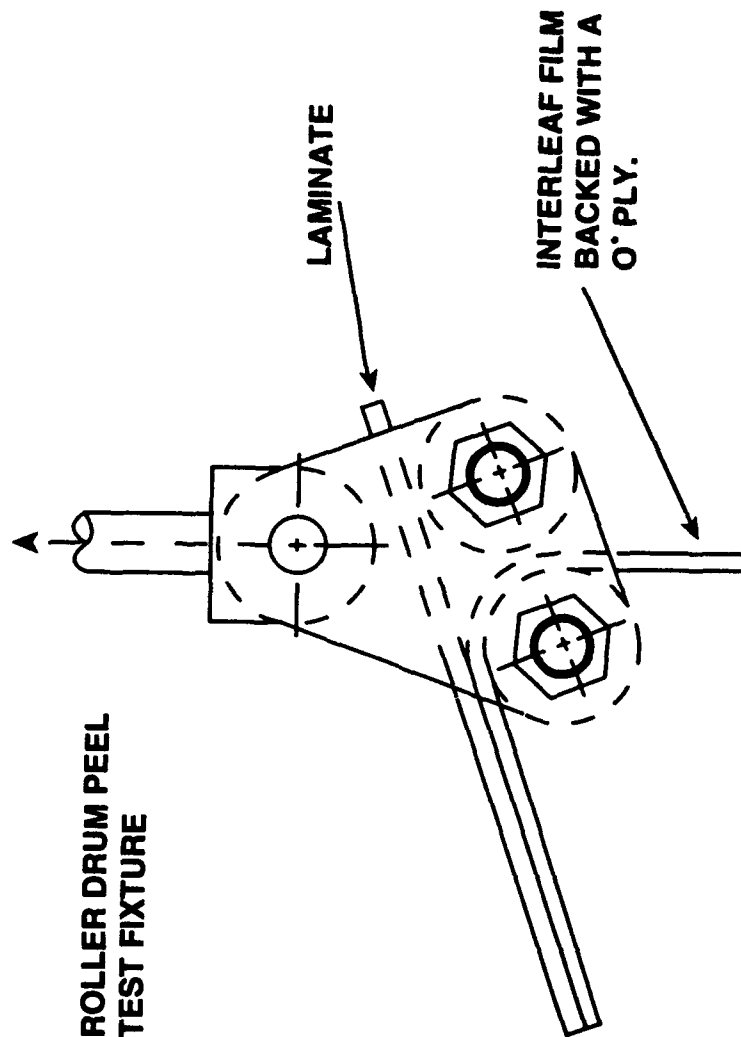
Figure 9. Schematic Of The Floating Roller Peel Test Set-Up.

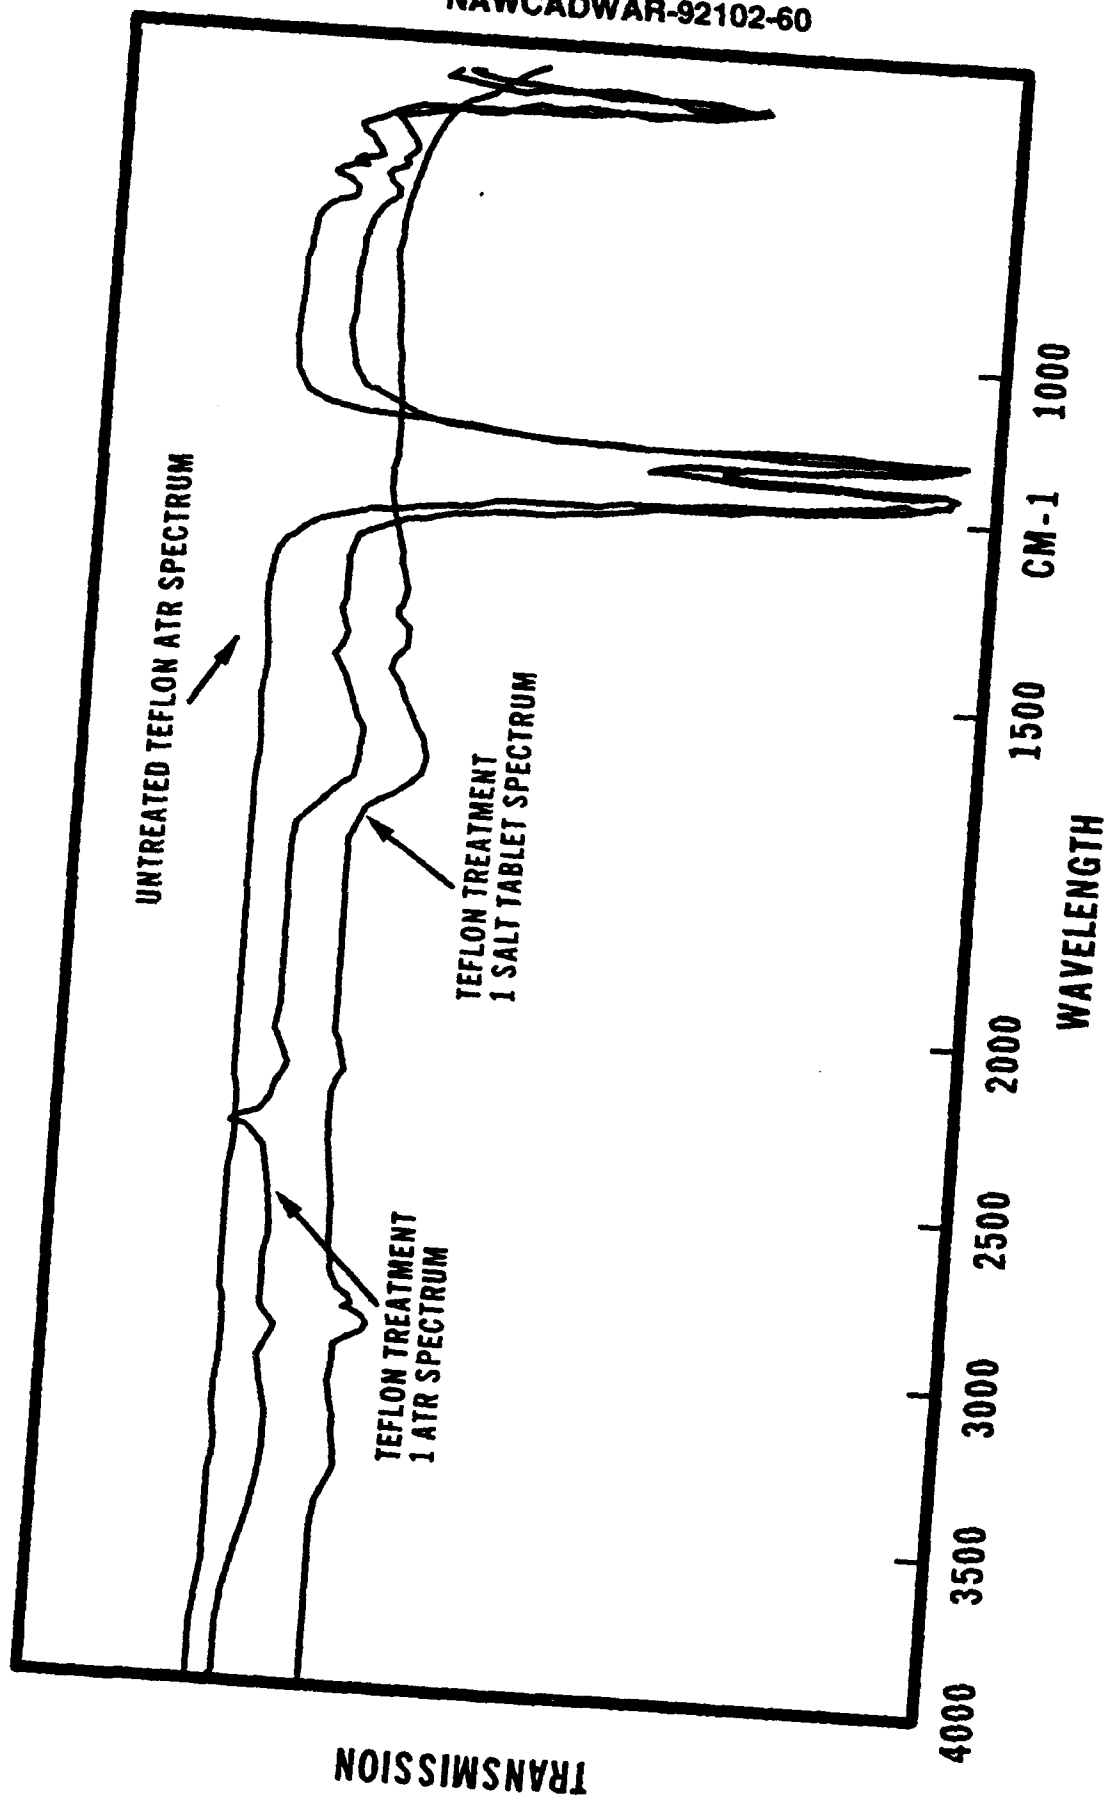
Figure 10. Transmission Spectra Of Untreated And Plasma Treatment One Teflon. Three Allylamine Valleys Are Visible On Spectra Of Plasma Treated Teflon Collected From A Salt Tablet And An ATR Crystal At  $3000\text{cm}^{-1}$ ,  $2100\text{cm}^{-1}$ , And  $1600\text{cm}^{-1}$ .

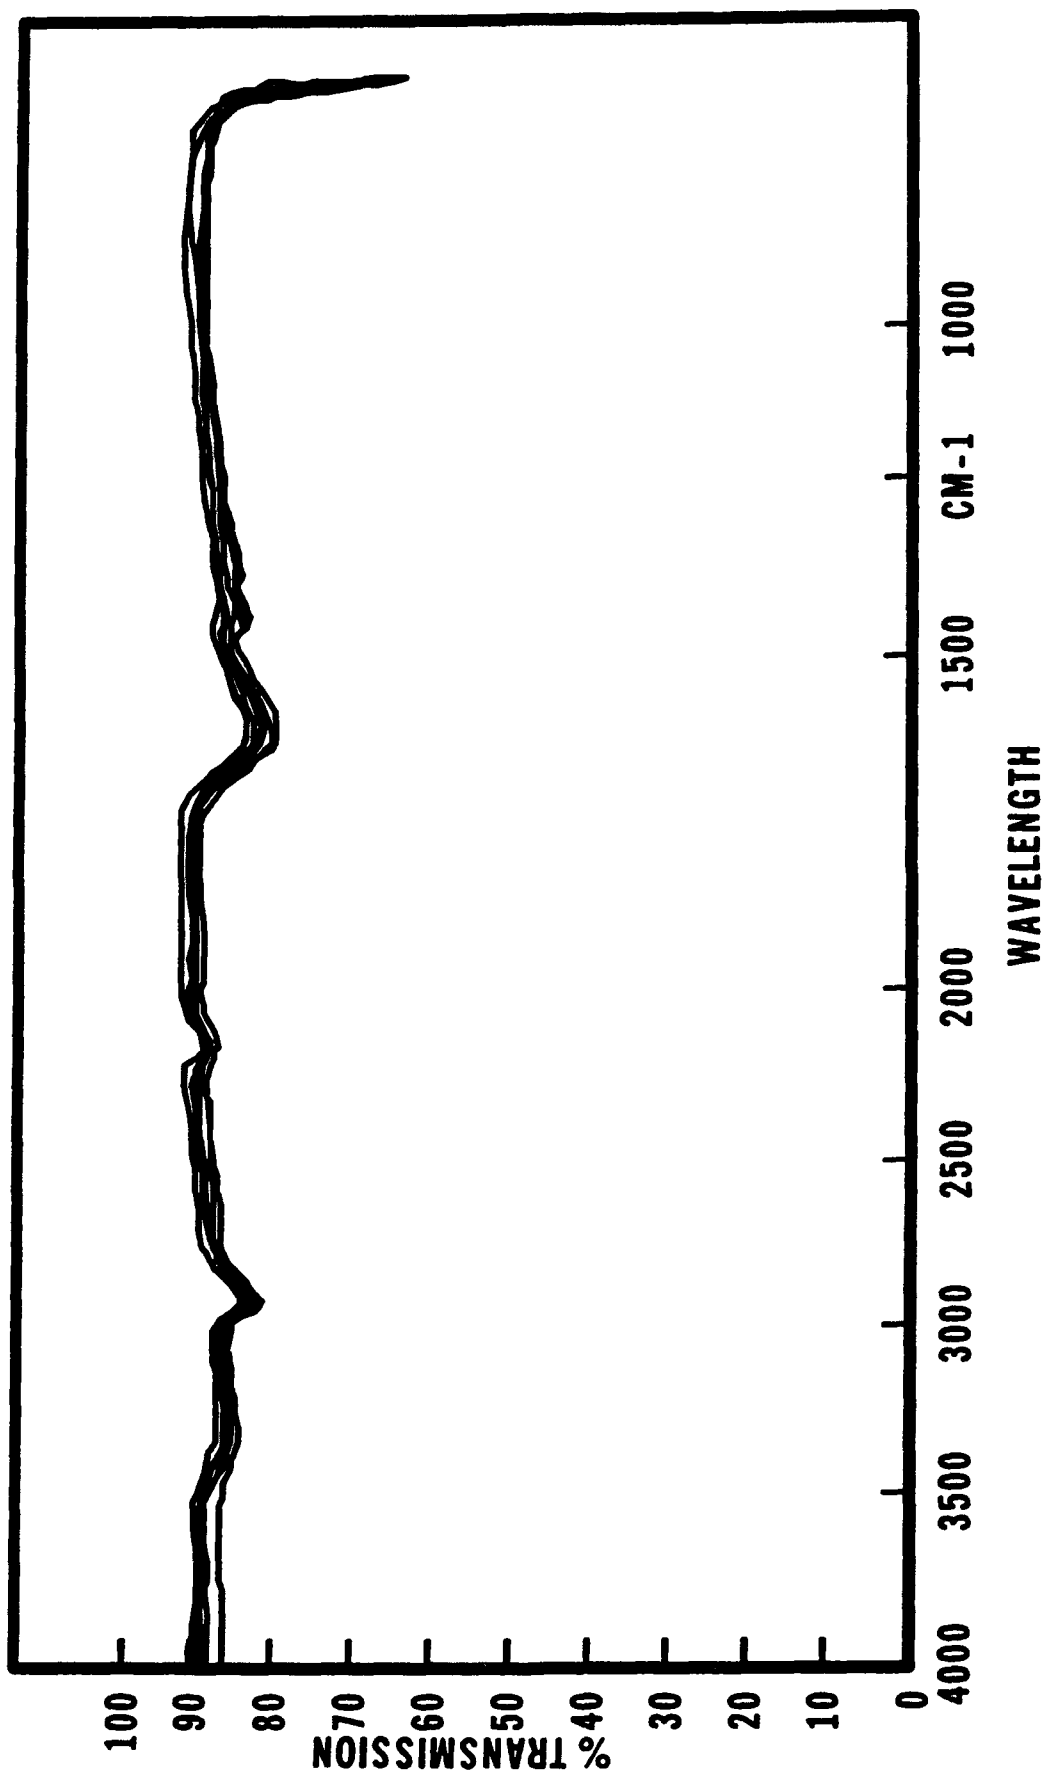
Figure 11. Reproducibility Of Plasma Treatments As Collected With Salt Tablets Placed In The Plasma Reactor During Film Treatment. Seven Different Batches Of Teflon Treatment One Are Plotted.

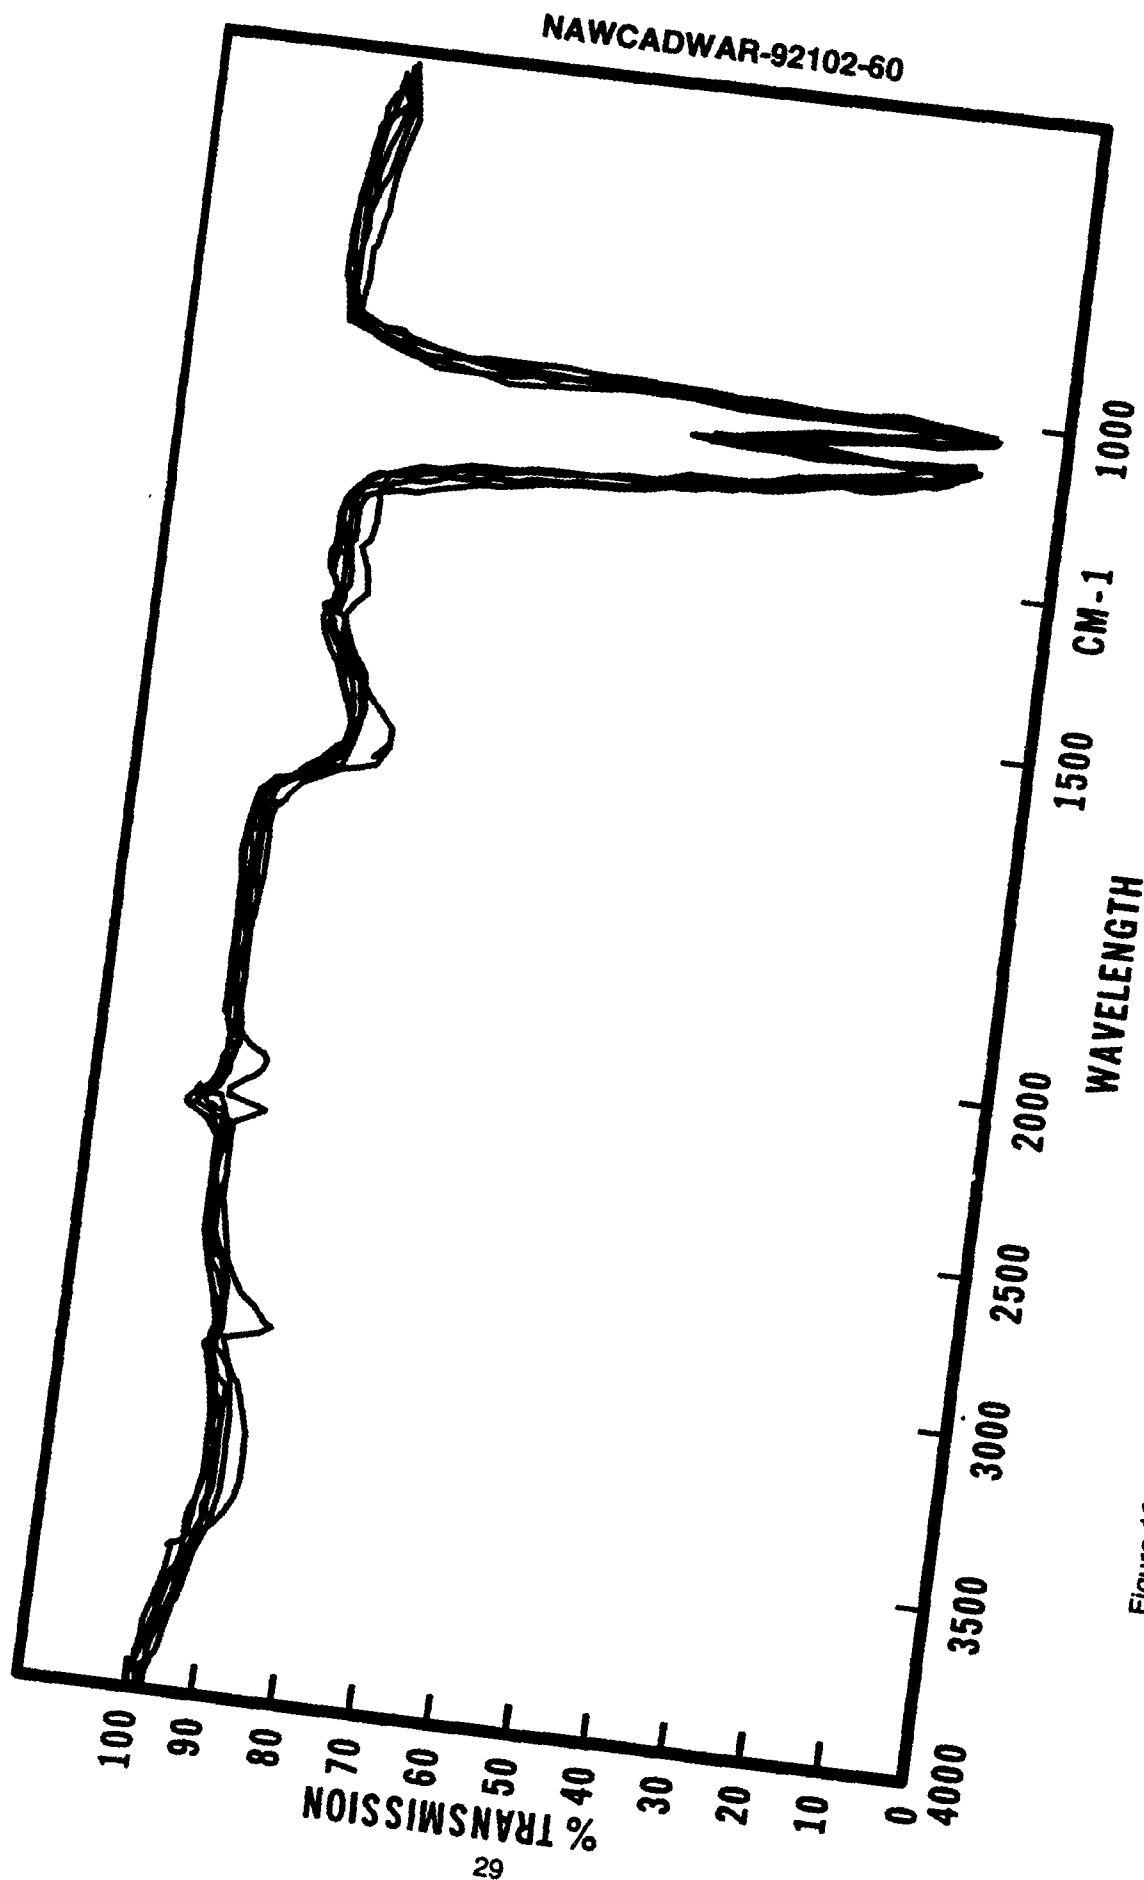
Figure 12. Reproducibility Of Plasma Treatments As Collected With ATR Spectra Of Treated Films.  
Five Different Regions Of A Teflon Treatment One Film Are Plotted.

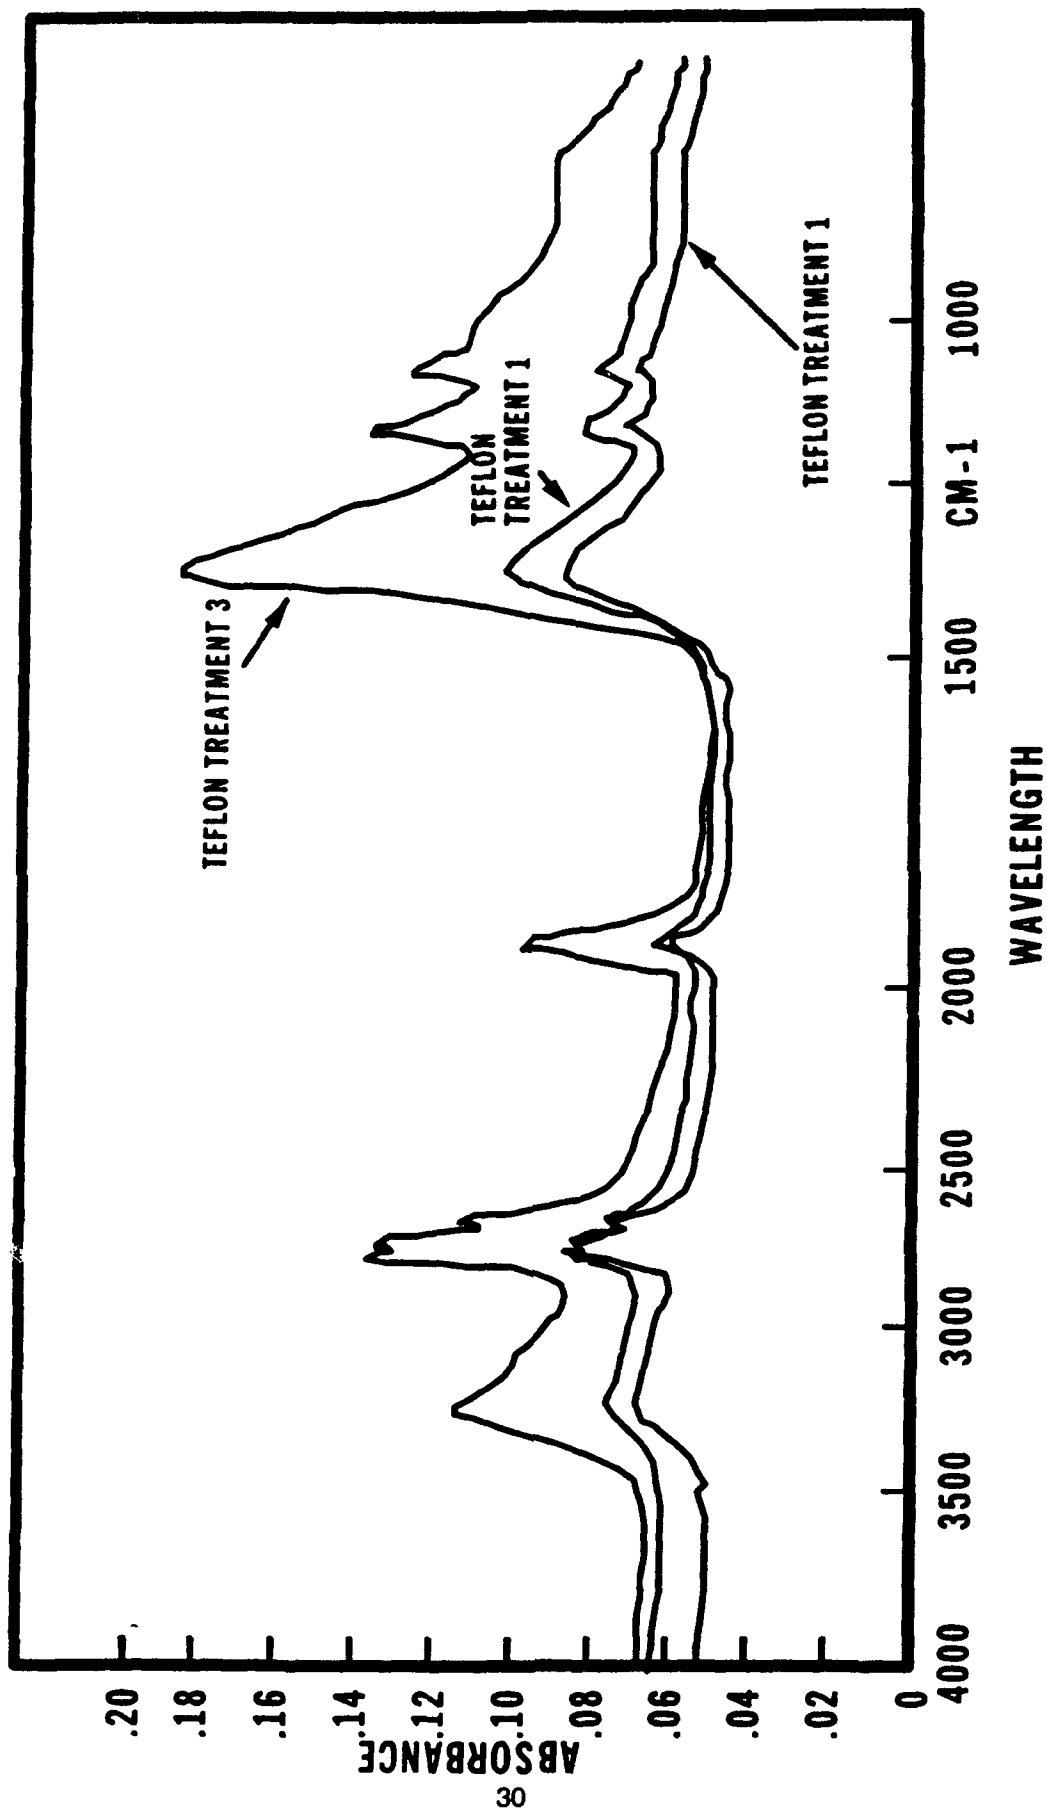
Figure 13. Absorption Spectra Of Plasma Treated Teflon. The Differences In Peak Intensity Due To The More Severe Plasma Treatment Are Greater Than Those Due To Variations In Reproducibility.

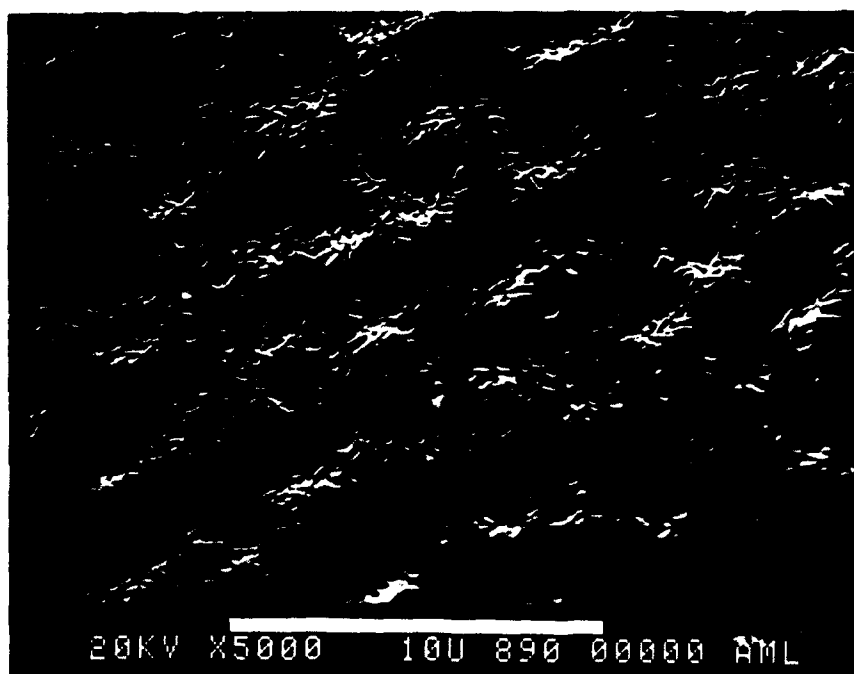
Figure 14. Untreated Teflon Film. Topography Is Marked By A Dendritic Structure.

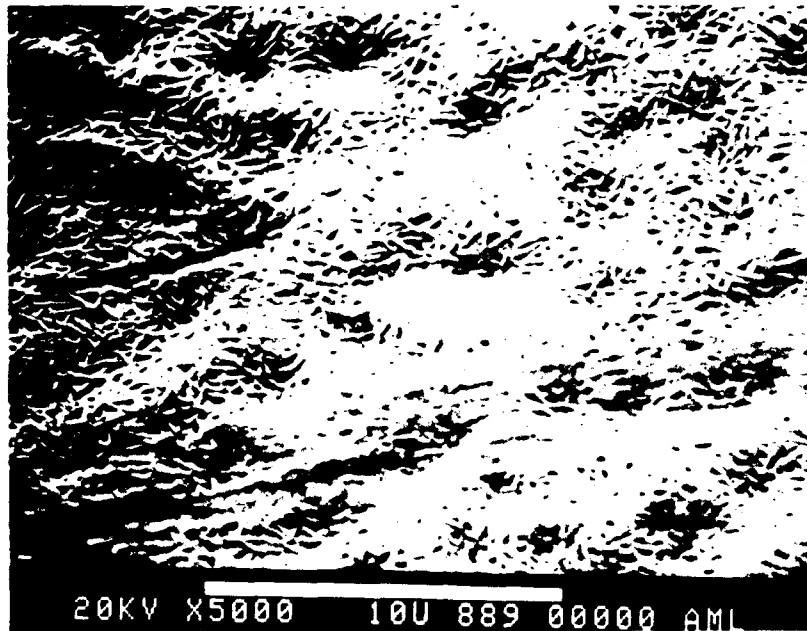
Figure 15. Teflon Film Treated With Treatment Two. Valleys In Film Topography Are Partially Obscured By Grafted Allylamine.

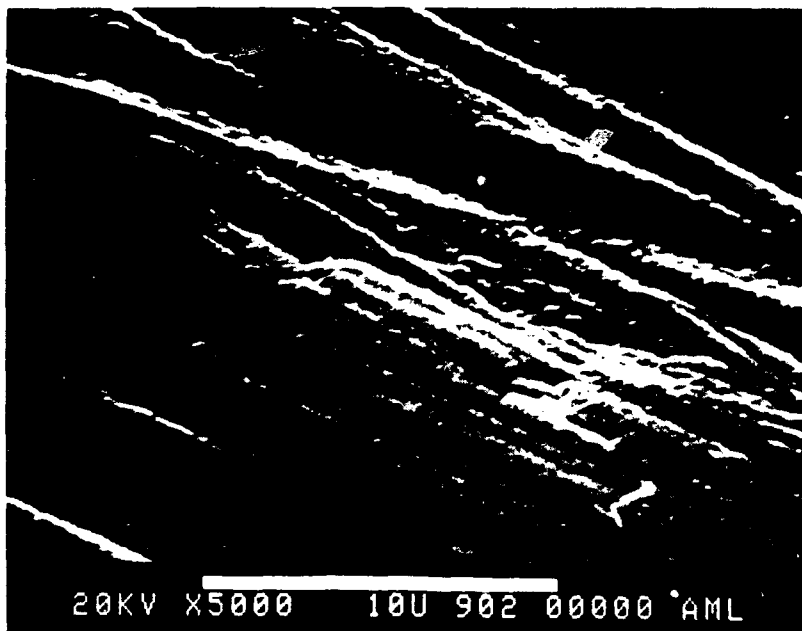
Figure 16. Teflon Film Treated With Treatment Three. Original Teflon Topography Is Totally Obscured By Plasma Treatment.

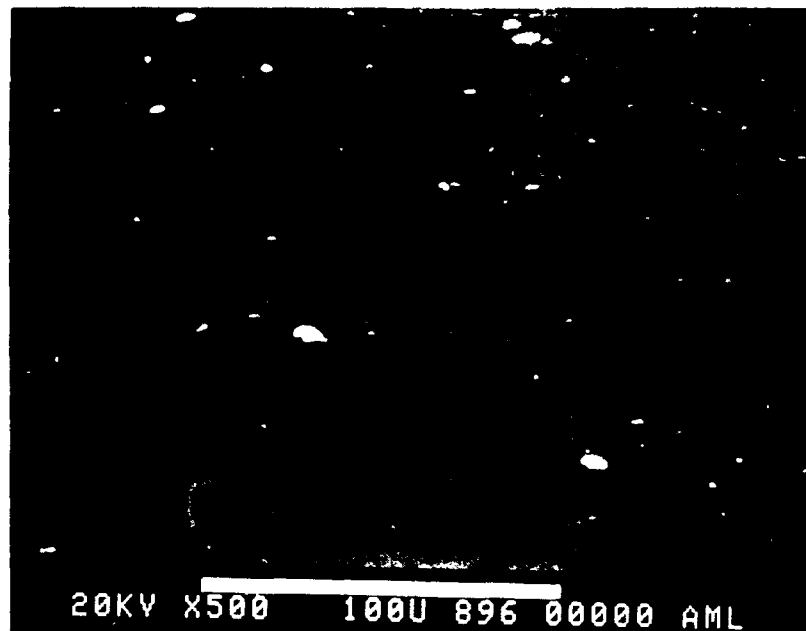
Figure 17. Kapton Film Treated With Treatment Two.  
Similar To Untreated Kapton Film Topography.

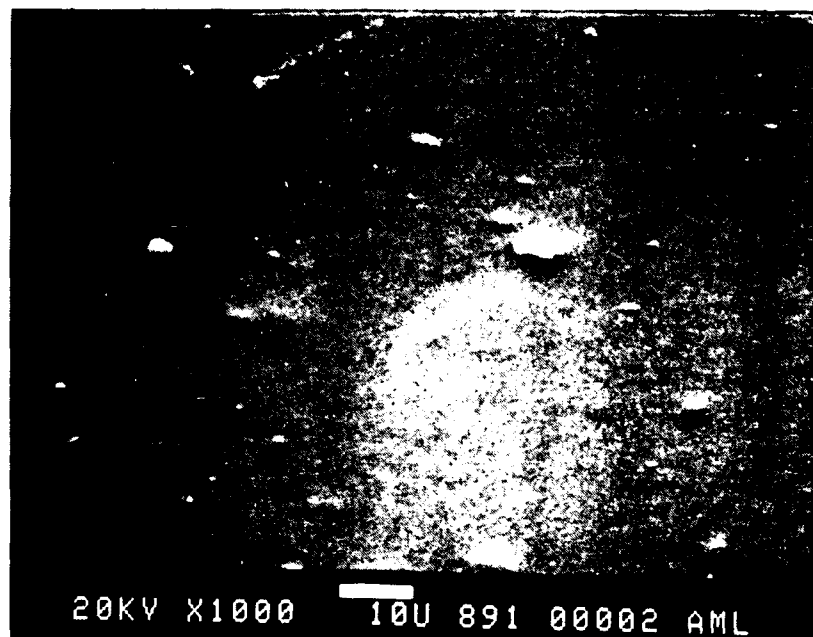
Figure 18. Untreated Kapton Film Failed In Tension. Failure Surface Is Featureless.

A comparison of the surfaces of tested tensile specimens from the treated and untreated films (Figures 18 to 21) indicates that the grafted-allylamine layer embrittles the film surface. The allylamine layer fails by cleavage. The vertical striations in Figures 19 and 21 indicate a brittle failure mode. The amount of deformation at failure is greater in the teflon film, and the surface striations are more widely spaced. The increased ability of teflon to plastically deform and tear as well as the high strain rate used in testing the teflon films contribute to the effect observed.

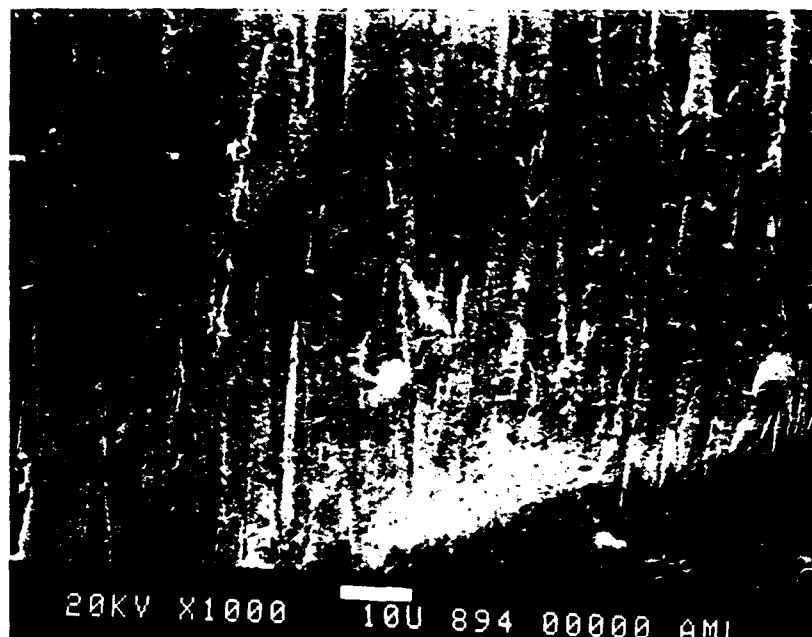
Figure 20. Untreated Teflon Film Failed In Tension. Outer Film Layers Deform And Tear Away From Film. Material Behaves In This Manner Since It Is Composed Of Several Thin Cast-Teflon Layers.

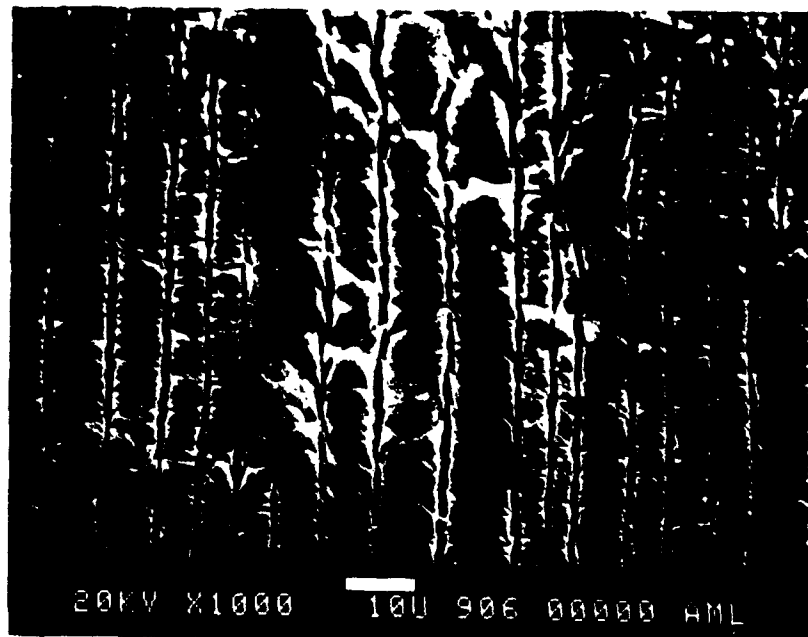
Figure 21. Teflon Film Treatment Three Failed In Tension Failure Surface Marked By Several Vertical Cleavage Striae. Within Each Stria The Failure Surface Is Cleaved At Several Locations.
